Manhole Inspection Summary

Manhole # S53C__015MH

Insp Date: **6/12/08 3:37 PM**

Location Address: **rear 110 n east st**

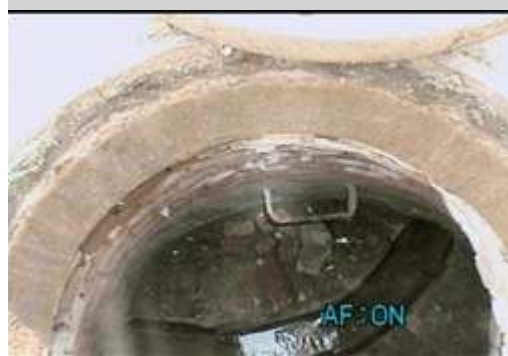
Defect 2

Steps Count: **2** Missing: **1** ☒ **Corroded**

bench debris

step

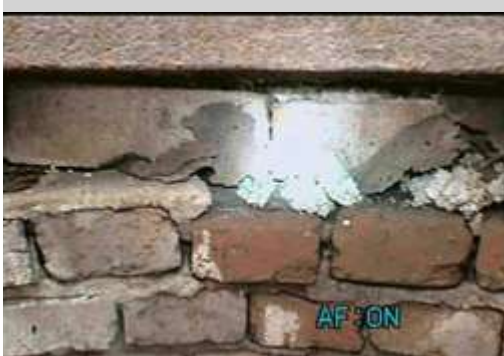
Defect 1

Condition: ☐ Sound ☐ Cracked ☐ Root Intrusion ☒ **Loose Brick** ☐ Deteriorated

Chimney loose bricks,
frame adj

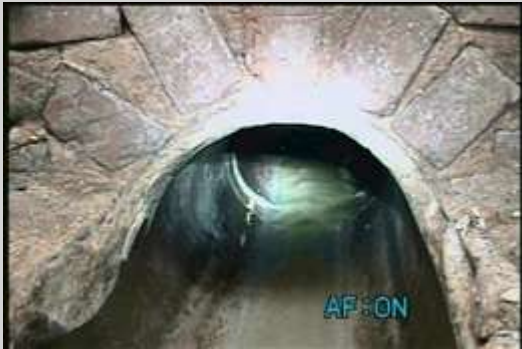
12 O'Clock Outflow

8 in. Circular Gravity Sewer
Pipe Out @ 12 O'Clock

Invert Depth: **6.09** (ft.) Flow Characteristics: **Slow**

Infiltration: **None** Pipe Seal Cond: **Unknown**

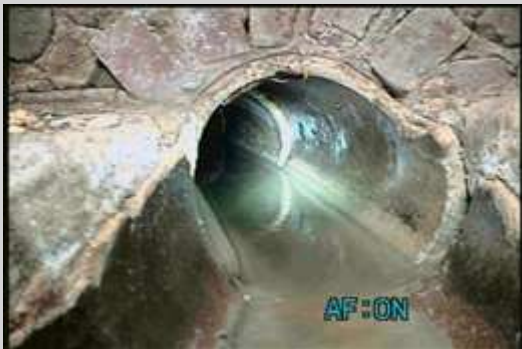
4 O'Clock Inflow

8 in. Circular Gravity Sewer
Pipe In @ 4 O'Clock

Invert Depth: **6.05** (ft.) Flow Characteristics: **Slow**

Infiltration: **None** Pipe Seal Cond: **Unknown**
